Articles reprinted from World Cement

REFKO MgO/Spinell monolithic solutions

READY FOR RAPID RECOVERY 6 REPAIR

Herbert Hoenl, REFKO, explains how successful and long-lasting emergency rotary kiln repairs can be achieved, resulting in safer operation of the kiln until a planned shutdown can take place.

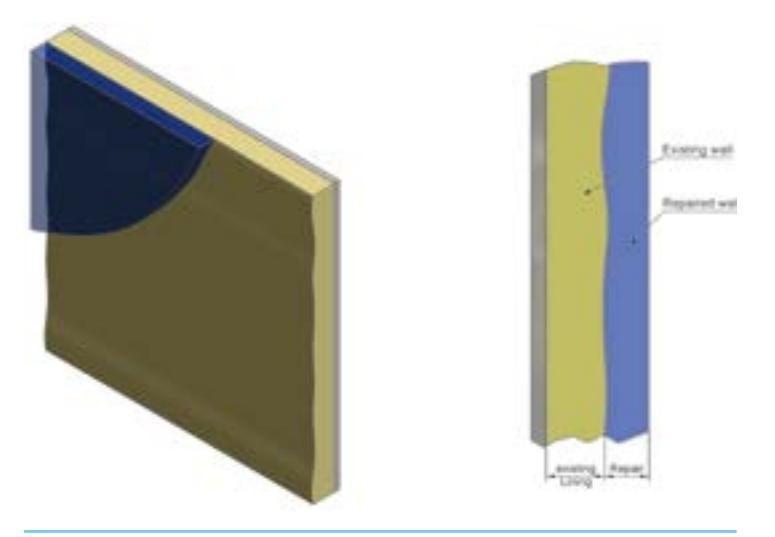
Lining sketch.

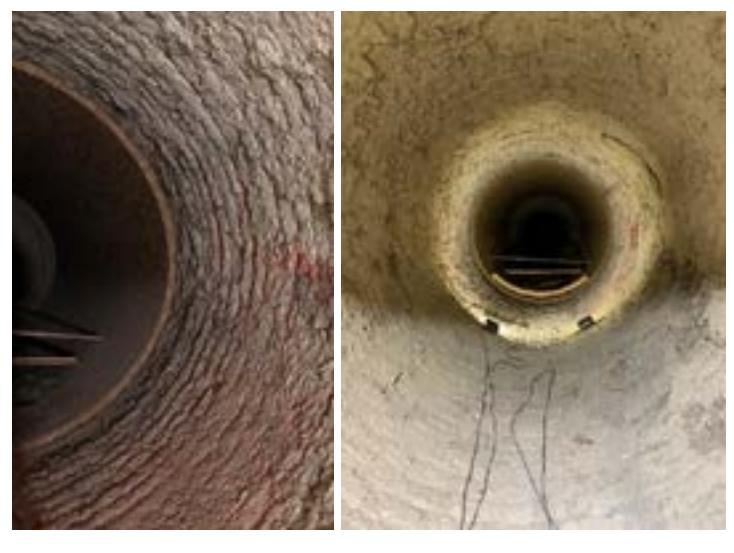
Premature wear of MgO/Spinel bricks.

In the area of the burning zone, in a kiln with a length of approximately 60 m and a diameter of approximately 4 m, a premature wear of the MgO/spinel bricks occurred. The affected areas were cleaned well with compressed air. All loose adhesions and dust deposits were also removed as much as possible by this process. Further pretreatment of the worn brick lining may also be necessary in cases such as these, depending on the damage pattern. The repair areas prepared in this way are usually divided into installation fields. Depending on the desired layer thickness, the use of anchors can also be considered. This must be decided individually 'on site'. REFKO does not recommend gun layers below 5 cm thickness.

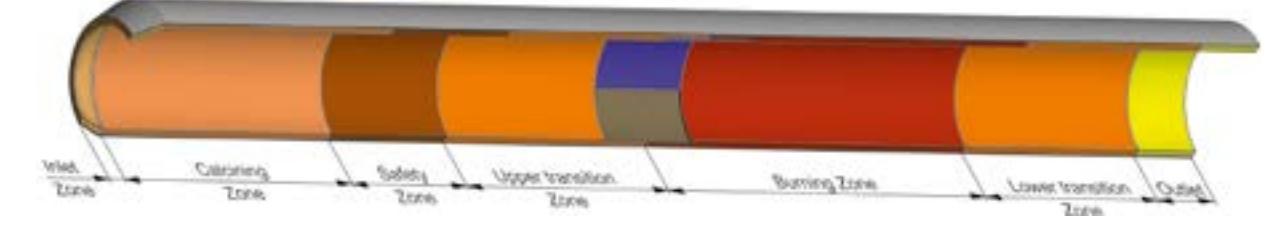
Sketch of a rotary kiln.

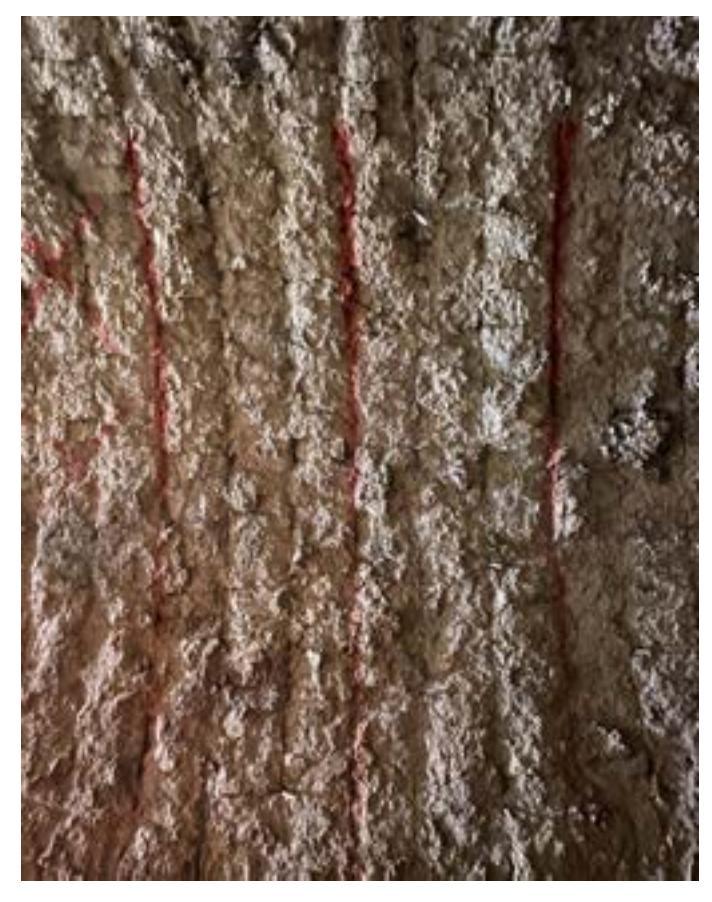
Cleaned surface and marking of the installation fields.

The installation fields are separated from each other by working joints and the joints should follow the stone joints. This is necessary to give flexibility to the mechanical loads in the heating up and operational phase, as well as the thermal expansion of the monolithic layer. To achieve optimal mechanical stability, complete rings should always be gunned. The selective repair of damaged areas is not advisable.

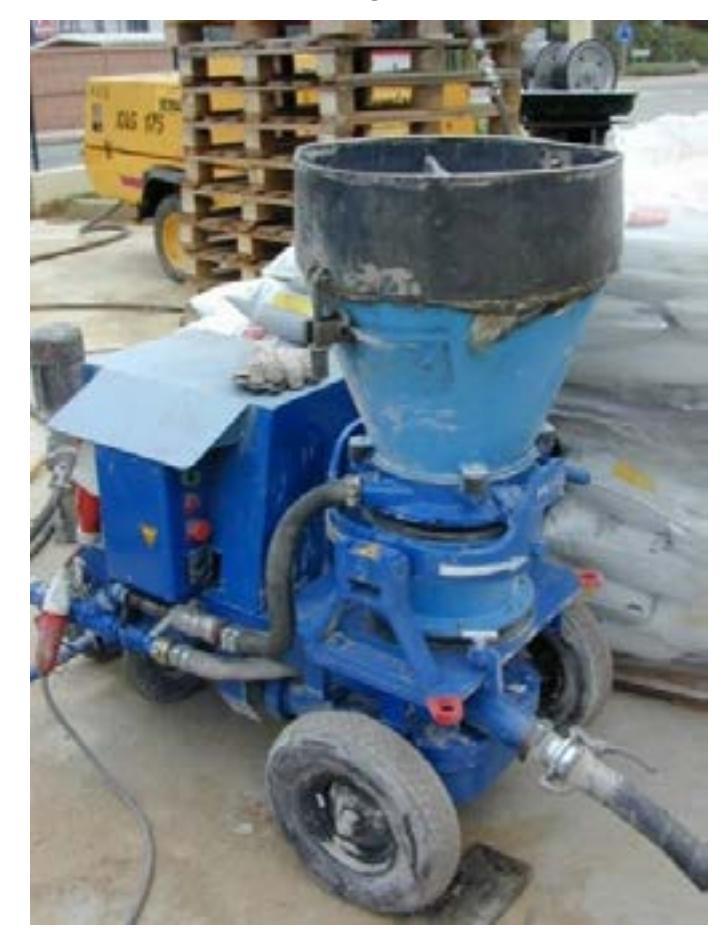
Example of a commercially available dry gunning machine.

The gunning of the REFKO Recovery MG concrete was carried out in this case with a commercially available dry- or respectively rotor-gunning machine. These machines are in use worldwide and can be easily organised for emergency repair work.

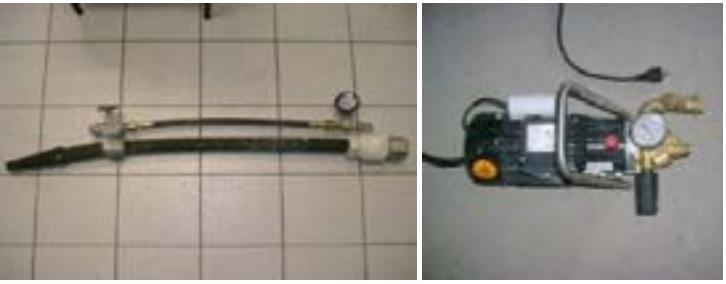
REFKO nozzle and high-pressure water pump.

The only special feature is the use of a high-pressure membrane spray nozzle, or the 'REFKO nozzle.' In combination with a high-pressure water pump, a practically dust-free gunning installation can be achieved and this special refractory concrete can be gunned with good results.

The REFKO nozzle and high-pressure water pump are now standard in many cement plants and installation companies. If, however, no REFKO nozzle and/or high-pressure pump are available, equipment will be provided by REFKO. Also, during the first installation of one of REFKO's technical service co-workers will always be on site.

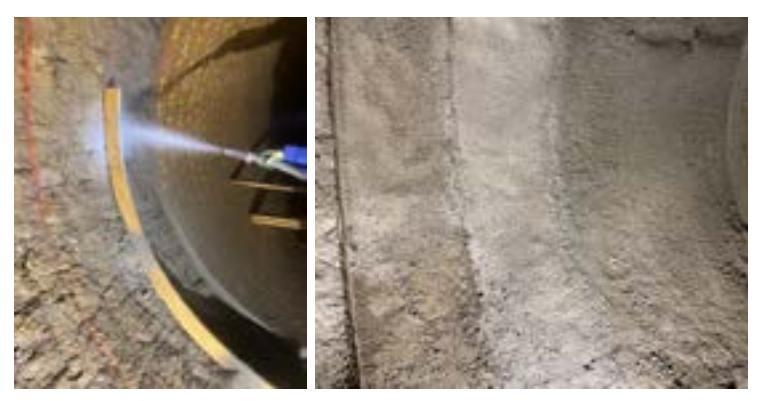
Almost dust-free gunning of REFKO Recovery MG (left) and repair zone after installation (right).

After setting, the concrete developed a stable connection with the subsoil, so that the furnace could be turned to the next mounting position without any problem.

The repair area was still completely preserved. A sintering connection with the subsoil could be detected in the post-mortem samples. No larger or more problematic formations of build-ups were detected. If a planned shutdown had not taken place, the repaired area could have lasted much longer.

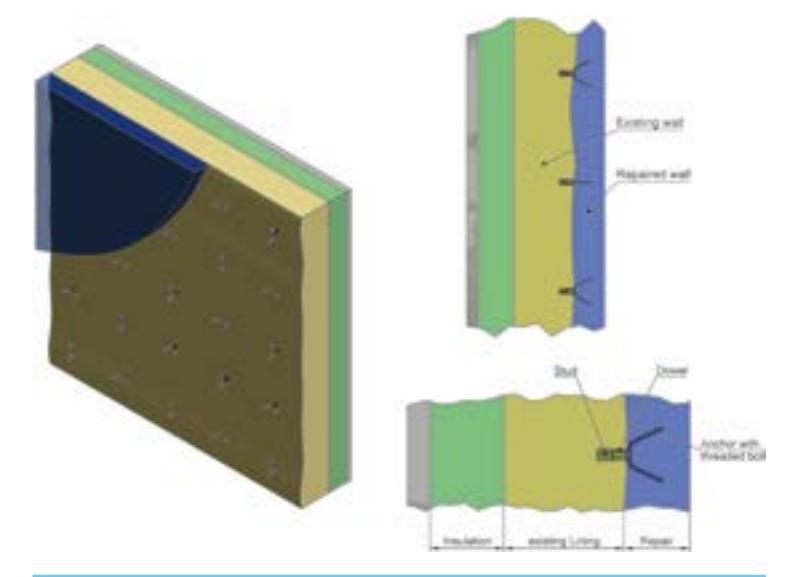
Sketch of lining, with insulation and anchors.

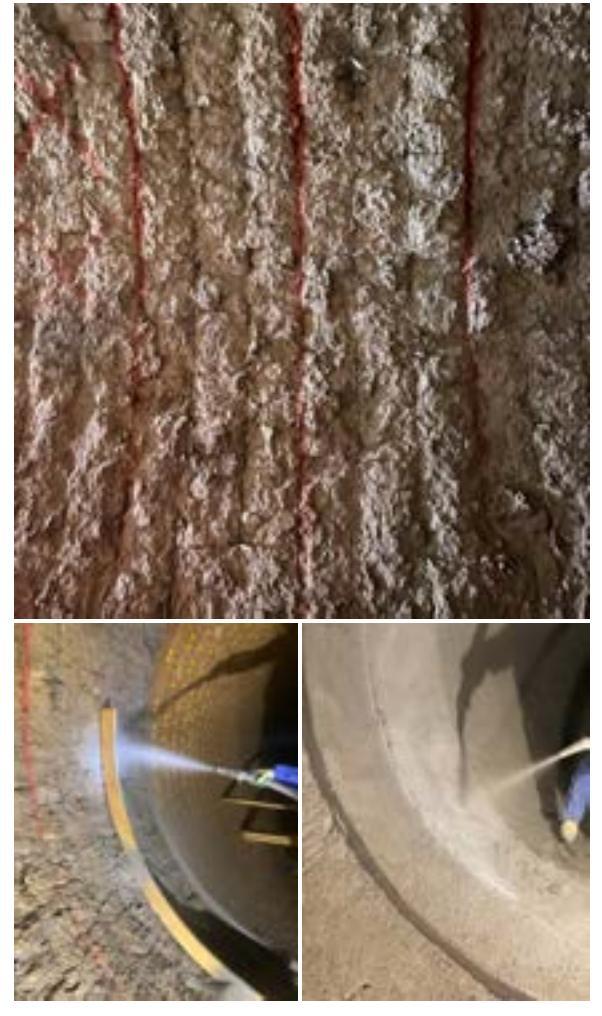
North Rhine-Westphalia: (top) old brickwork, almost dust-free gunning with field classification. (Bottom) final result after installation.

- Furnace length: 60 m.
- Kiln diameter: 3.8 m.
- Installation point: kiln 7 10 m (burning zone).
- Layer thicknesses: 10 90 mm (partly tapered to 0).
- Running time: 11 weeks.

Good adhesion with the old brick lining was achieved right from the start. In each case, whole quarters were sprayed in the corresponding lining width. After initial stiffening, the kiln was rotated, and quarter after quarter was sprayed. For the lining of an area of approximately 38 m³, a time of approximately 12 hours was required. After 24 hours of drying, the kiln was started up with the plant-specific heating-up curve without any problems or disturbances. Regular thermal imaging camera shots of the lining area were inconspicuous over the entire run time, which in any case indicated that there was no major damage to the lining. Even afterwards, during the main inspection, a residual thickness of the spray lining with REFKO Recovery MG 78 was still visible at all points, even where only a few millimetres had been applied.

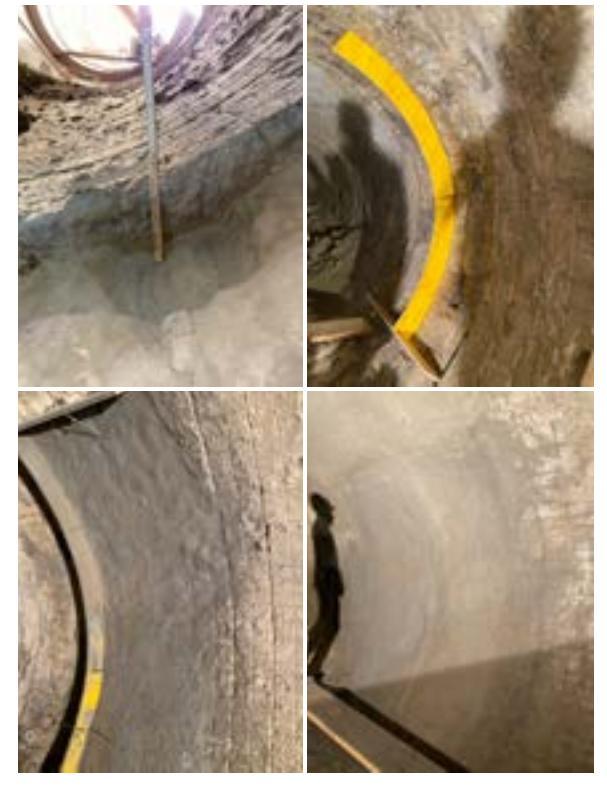
South Austria: Old masonry and discernible thickness of application, field grading, final result after installation.

- ► Kiln length: 49 m.
- Kiln diameter: 3.4 m.
- Installation location: Kiln 14.20 15.60 m (burning zone).
- Layer thickness: 20 180 mm.
- Running time: 13 weeks (until annual inspection).

A damaged area was also repaired in the burning zone. The approximately 1.4 m were divided into two sections. The refractory consumption for this area amounted to 3.5 t of gunning material. The lining, including all necessary preparatory work, took 10 hours. According to the furnace operator, the lining with bricks in this area alone would have taken at least 24 hours, plus the effort of moving the appropriate equipment into the furnace. After the completion of all the work in the kiln it was brought up to operating temperature within 36 hours. Despite an emergency shutdown of the plant in the area of the cyclones one month after lining, the kiln ran through until the scheduled inspection and showed no abnormalities. Here, too, the Recovery system can be used as a preventive measure to extend kiln downtimes until the next scheduled stop.

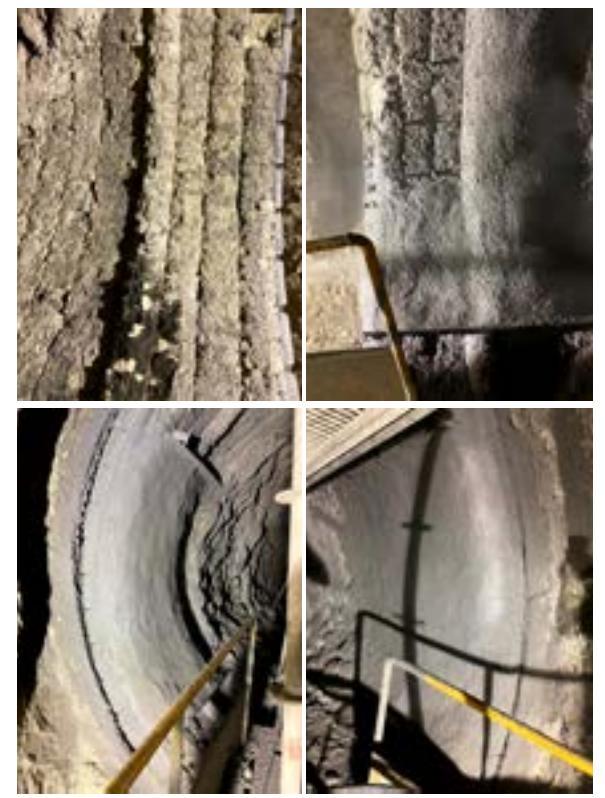
- Kiln length: 60.5 m.
- Kiln diameter: 4.2 m.
- Installation point: Kiln 0 1.2 m (outlet zone + outlet cone).
- Layer thickness: 130 150 mm.

- ▶ Kiln length: 60.5 m.
- Kiln diameter: 4.2 m.
- Installation point: Kiln 18 23 m (burning zone) + kiln 0 – 1.2 m (outlet zone + outlet cone).
- Layer thickness: 100 150 mm.
- Running time: Both kilns are still in operation without any abnormalities.

Turkey: Old brickwork outlet zone, before and after installation with REFKO Recovery MG 78.

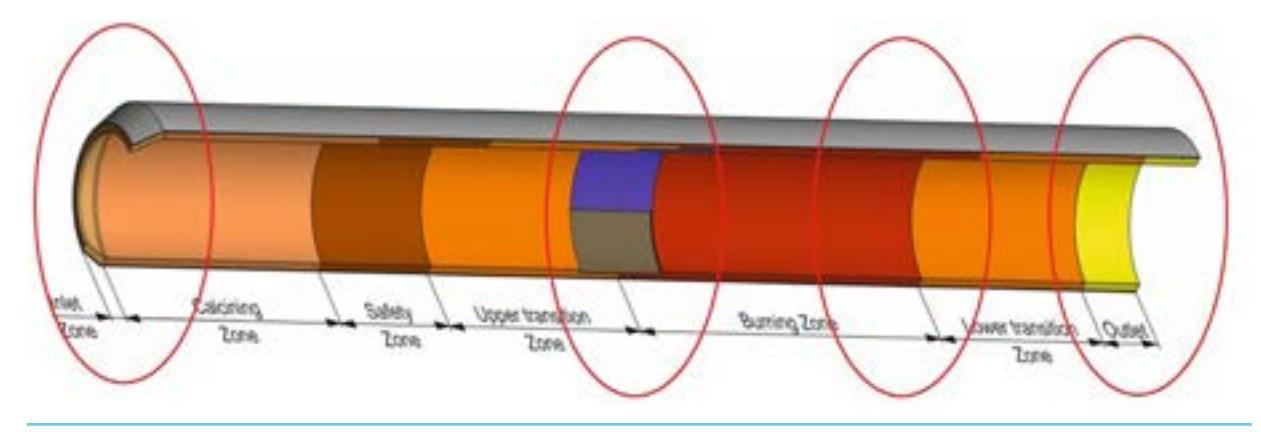
Installation areas of the previous field tests until now.

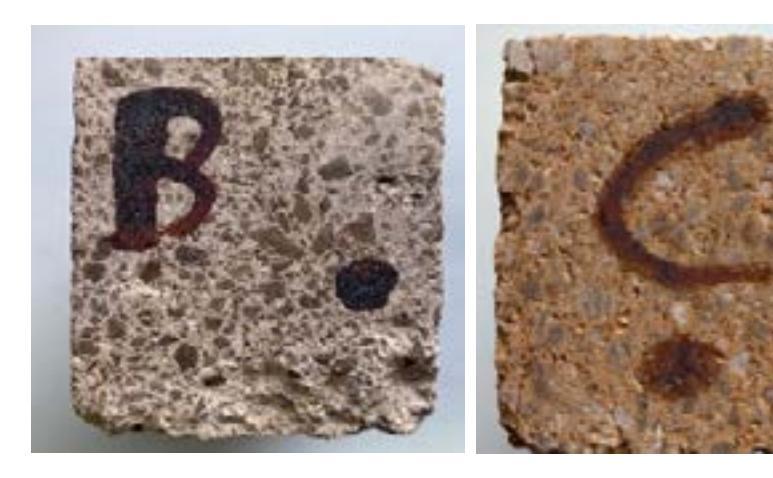
Figure 1. (Left) VIMAG SP 86 B with no cracks. (Right) Magnesia spinel brick with no cracks.

Neither the brick sample nor the castable sample showed any cracks after having cooled down 20 times (Figure 1). This is, for both products, a very good result. It can therefore be argued that Vimag SP 86 B is on the same level as common magnesia spinel bricks in terms of TSR.

The probes were heated up to 1200°C and held at this temperature for 4 hours. The probes were then taken out of the furnace and allowed to cool down at normal room temperature for 30 minutes.

After this, the probes were placed back into the furnace, which was still at 1200°C. After being held at 1200°C for another four hours, the cool down process started again. This was done 20 times, after which, an optical inspection of the probes was conducted.

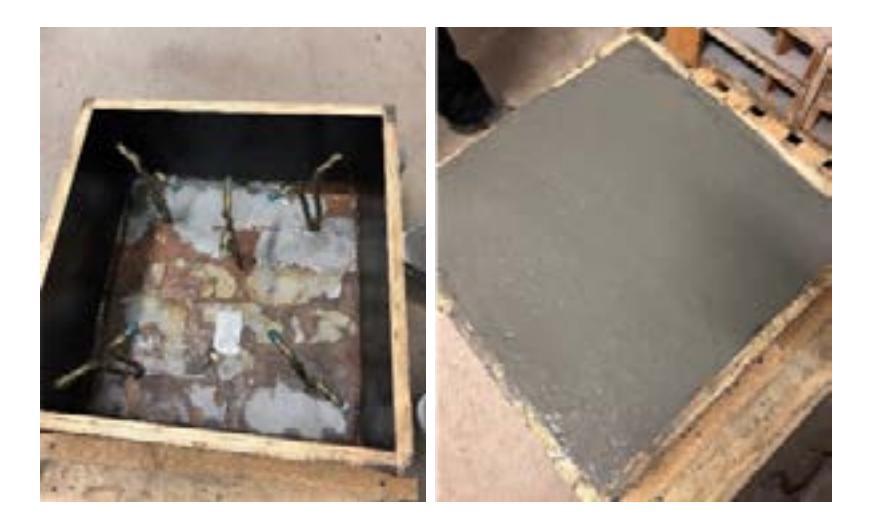
Figure 2. A block of the castable solution was cast and then used as the door of the test furnace.

A block, including anchors, with dimensions of 500 mm x 500 mm and a thickness of 250 mm was cast (Figure 2). This block was then used as the door of the test furnace. The furnace was then heated up following a procedure obtained from a cement kiln operator. Once cooled, the block was inspected for cracks. In this instance, no cracks were found after the test (Figure 3).

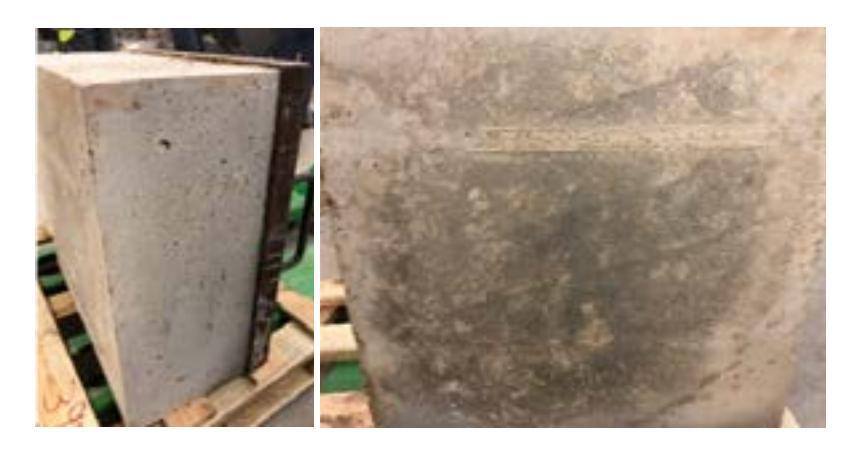
Figure 3. No cracks could be found in the cast block after the kiln heating up procedure.

Evidently, the rotary kiln can be heated up under the same heating-up schema that is valid for the normal start of a kiln after
